SUSQUEHANNA RIVER BASIN
LAKE STRAUSE DAM
LAKE STRAUSE INCORPORATED

NDI NO. PA-01010,
DER NO. 38-068

LEBANON COUNTY, PENNSYLVANIA
PHASE I INSPECTION REPORT
NATIONAL DAM INSPECTION PROGRAM

JULY 1981

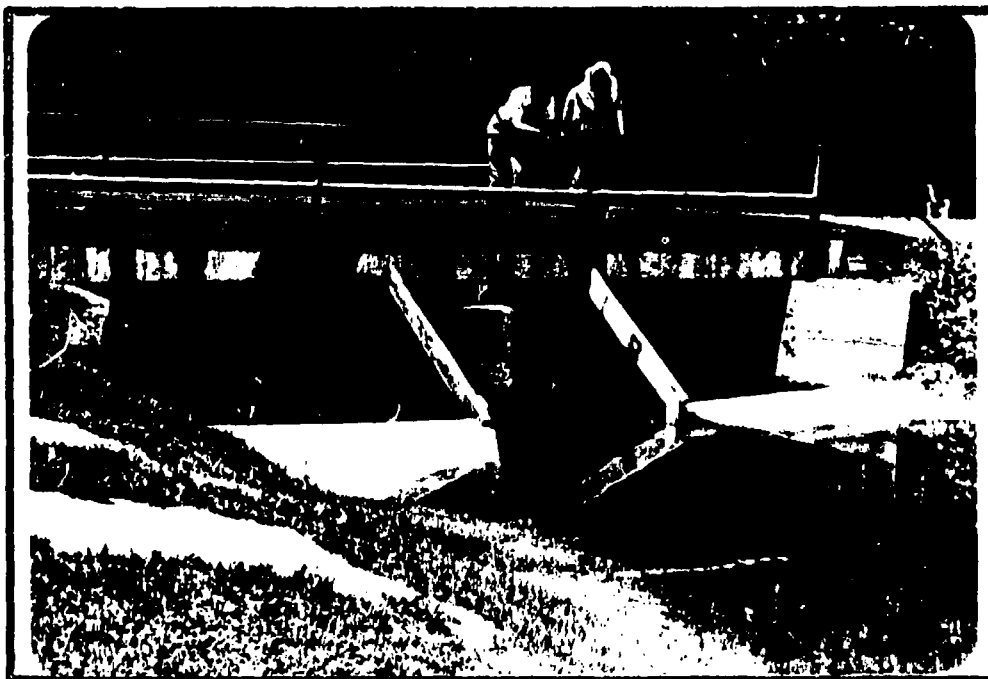
The spillway is located near the left abutment and consists of a 24 foot wide, broad crested weir with a low flow diversion. This diversion was created by placing two pieces of telephone poles on the approach to the weir. The upstream side has a concrete approach to the top of the poles. Struts are placed against the bridge to support the

ends of the poles (Photograph No. 7). A two-span bridge with a center pier crosses the spillway. About 16 feet downstream of the bridge, the concrete discharge channel drops vertically 3.5 feet (Photograph No. 8), and from this point the channel is a rock lined channel. The concrete section, from the weir to the drop, is in fair condition with only minor deterioration.

It was noted that the wooden low flow diversion on the spillway was not secured tightly. The possibility exists that this device could break loose and obstruct the spillway.

The concrete, broad crested spillway appeared to be in good condition. The construction of the low flow diversion by placing the telephone poles does not affect the structural stability. The struts and loose poles could, however, restrict the waterway opening.

WEIR OF SPILLWAY AND ROADWAY BRIDGE NO. - 7

4. That the struts in the spillway be removed and that the wooden waterway diversion poles be secured by other means.
5. That a formal surveillance and downstream warning system be developed for use during periods of high or prolonged rainfall.
6. That an operation and maintenance manual be prepared for guidance in the operation of the dam during normal and emergency conditions, and that a schedule be developed for the annual inspection of the dam and its appurtenant structures.

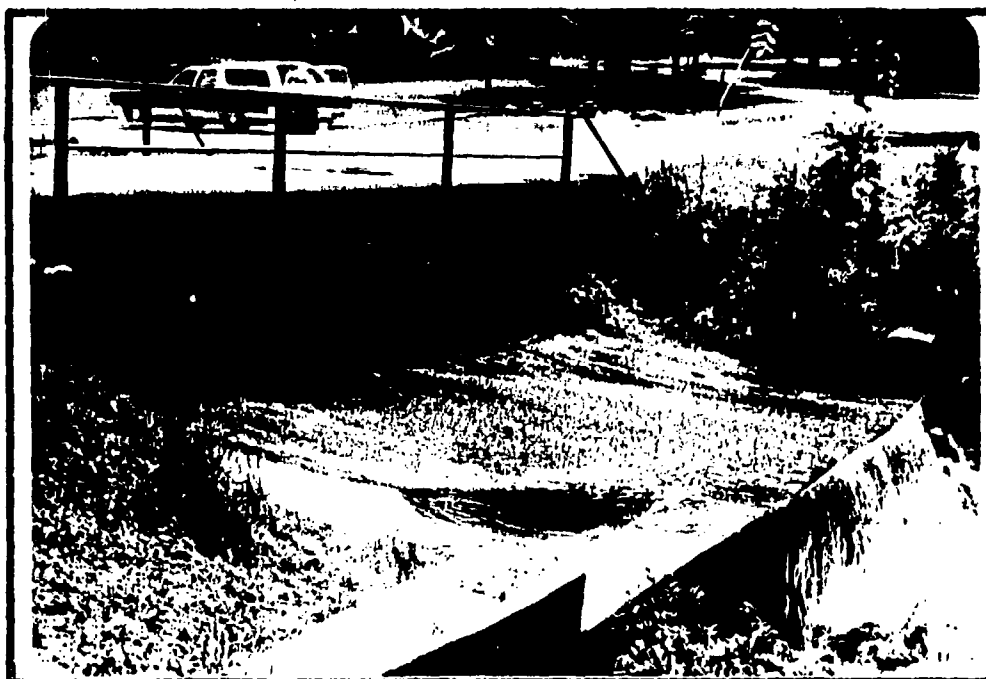
DOWNSTREAM END OF SPILLWAY NO. - 8

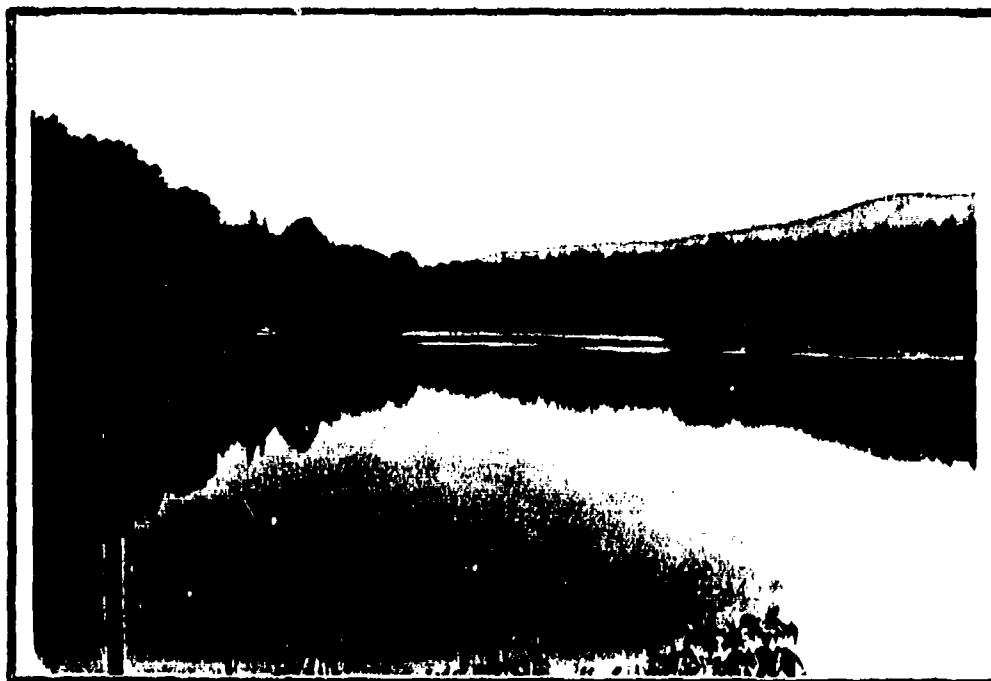
OVERVIEW OF RESERVOIR NO. - 11
